PROPERTY INSPECTION REPORT

Prepared For: Happy Homeowner
(Name of Client)

Concerning: 1234 Sunshine Street
(Address of Inspected Property)

September 19, 2009
(Date)

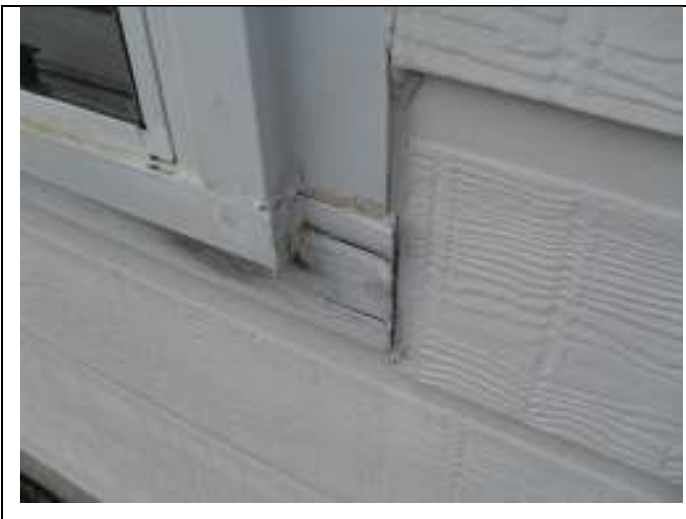
3. Wood rot was noted at the rear exterior trim around one of the living room windows and at the base of the trim on the rear living room side corner of the house. Unable to determine the condition of the underlying materials.

Sample of wood rot of rear exterior trim

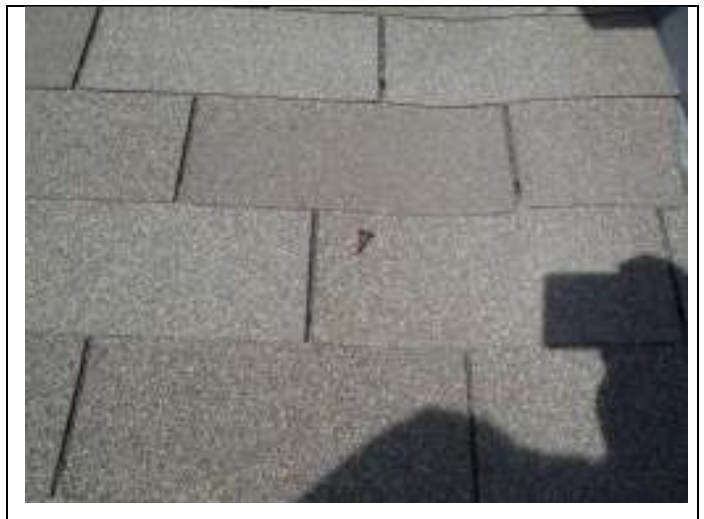
Sample of exposed nail in the roof

2. There is at least one exposed nail on the roof, by the front entry. Recommend a roofer be consulted for further evaluation/repairs and check for other repairs that may be needed at that time.

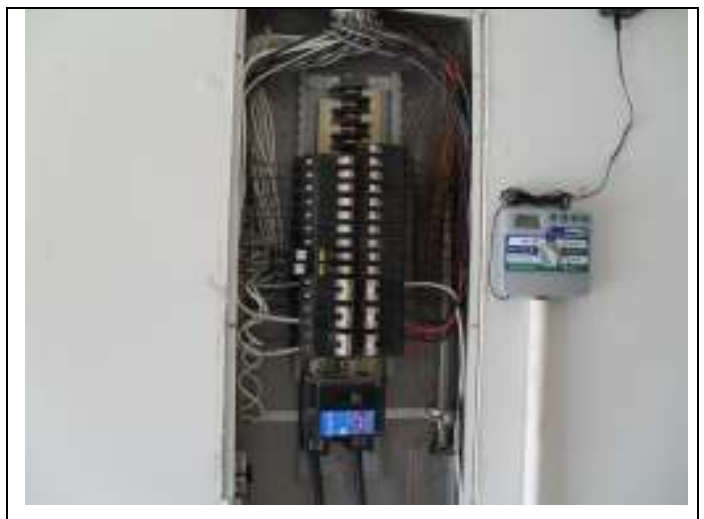
Photo of main electrical panel with cover removed
